STRUCTURAL FATIGUE TEST RESULTS FOR LARGE WIND TURBINE BLADE SECTIONS

J. R. Faddoul and T. L. Sullivan
NASA Lewis Research Center
Cleveland, Ohio

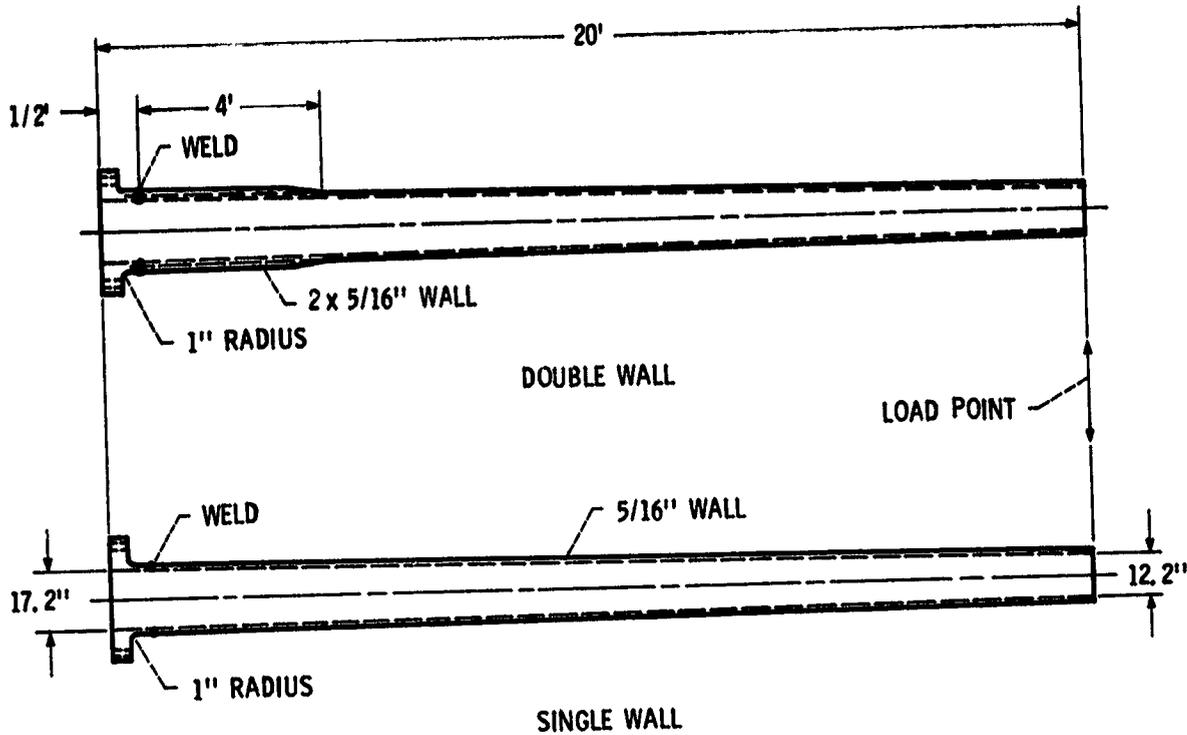
Application of standard welding codes, such as the Structural Welding Code, to this weld resulted in the requirement of close interval (100 hour) inspections. To better ascertain inspection requirements of this weld, a root end specimen was tested in the Ft. Eustis facility. In addition, a prototype of a second root end design was also tested. This design consisted of a double wall at the root end. The outer tube was swaged over the inner tube. The purpose of the double wall was to reduce the stress in the critical spar-to-flange weld. Sketches of both the single wall and double wall specimens are shown in Figure 13. The results of these tests and the conclusions drawn from them follow.

Figure 13. - Steel spar test specimens.

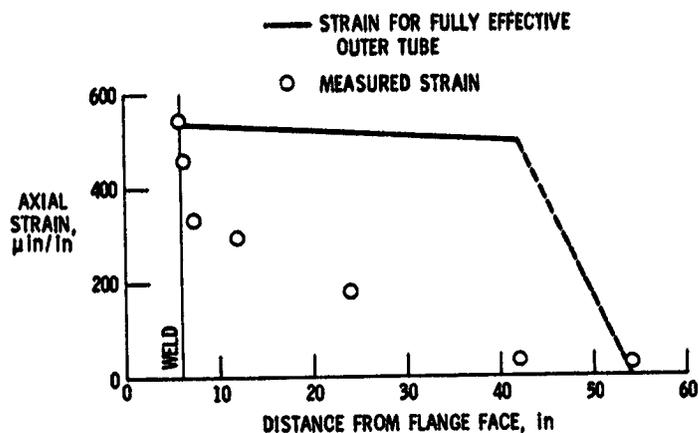
Analysis of the failure consisted of examining strain gage data and reviewing the Structural Welding Code in an attempt to categorize the double wall spar weld. In Figure 17, calculated strain is compared with measured strain on the outer tube. The calculated strain assumed the outer tube was fully effective in bending except in the tapered outboard section. The figure shows that the outer tube is much less than fully effective, which means the inner tube is picking up additional load. The high strain gradient near the weld indicates high shear stresses at the weld. The measured strain just inboard of the weld is very close to that calculated and about half that measured on the single wall spar for the same applied load.

Figure 17. - Comparison of calculated and measured strain in double wall steel spar for an applied load of 10,000 lb.

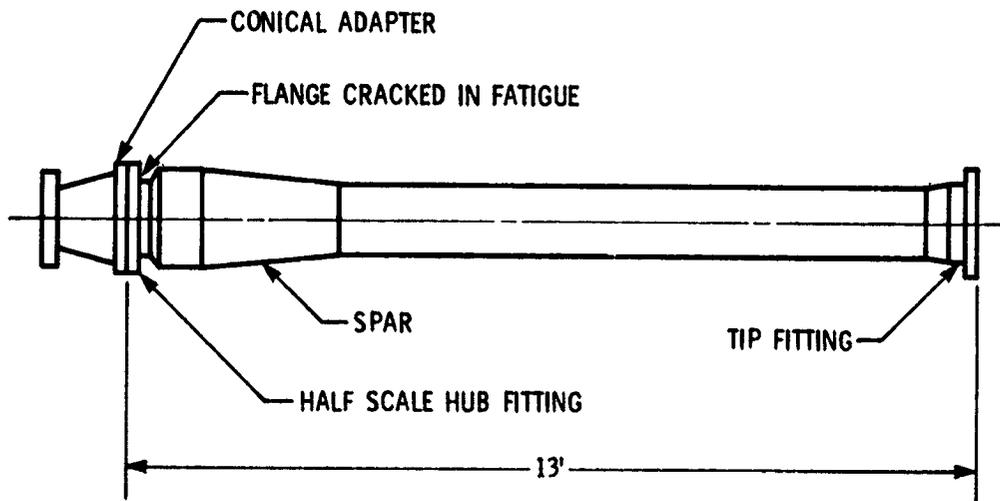
To reduce costs, half scale specimens were used for fatigue testing. A sketch of the specimen is shown in Figure 20. Two specimens were fabricated; the first specimen (bonded) was fabricated in the same manner planned for the full scale blade while a release agent was applied to the retention ring of the second specimen (unbonded) so that the retention capability of the mechanical lock could be tested.

After 4×10^6 cycles at lower load levels, both specimens failed after about 350,000 cycles at the hurricane load level. (The hurricane load was defined as a pressure of 50 pounds per square foot applied flatwise to the blade.) In both cases, failure took place in a 1/16 inch flange fillet (Figure 20). Visual and tap test inspection of both specimens revealed no apparent damage in the retention area other than the flange failure. Definitive determination of damage will require sectioning of this area. This is planned for the near future.

Figure 20. - Half scale composite blade hub joint fatigue test specimen.

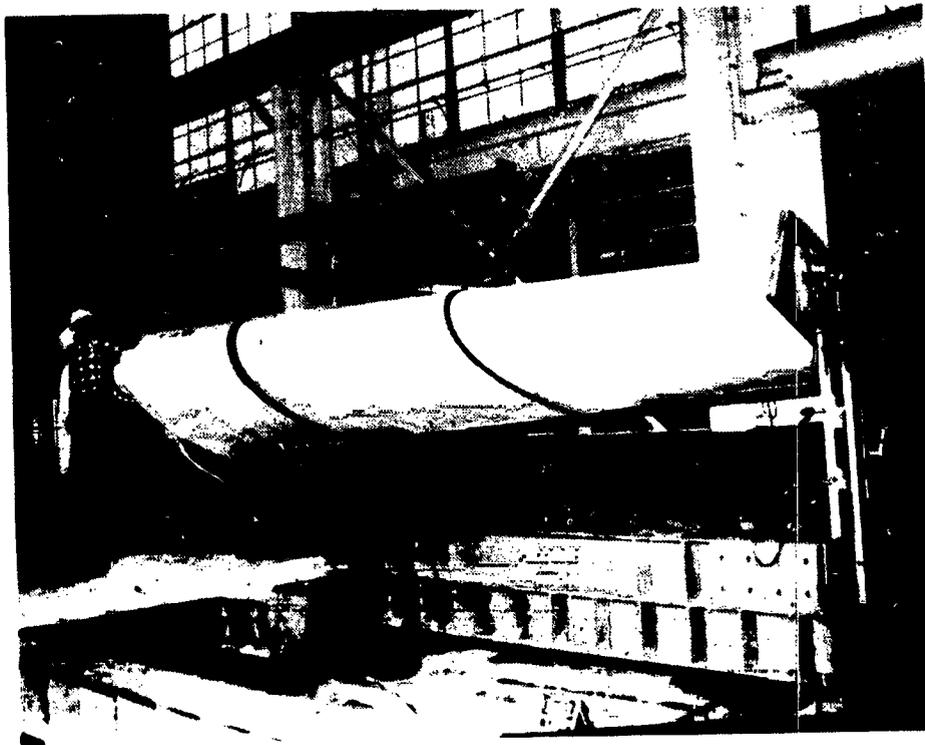
As mentioned earlier, fatigue testing of blade sections is not considered to be a quantitative test in that it will not predict the number of hours a blade will operate satisfactorily on a field machine. This type of testing is, however, very effective in highlighting design deficiencies or over-stressed areas (structural "hot spots") in specific blade locations (generally the root area). As a means of proving test effectiveness, one of the aluminum blades from the original three blades built for the Mod-0 (100kW) wind turbine was modified to be a fatigue test specimen. Details of the blade design and construction are contained in Reference 6. The modification consisted of cutting the 62.5 foot-long blade approximately 21 feet from the root end flange. The cut section was then reinforced for introduction of shear loads by slipping on a one-inch thick aluminum plate (with the airfoil section cut out of the middle) and rigidly fixing the skins, stringer, and trailing edge channel to the plate. Another one-inch thick aluminum plate (without airfoil cut out) was then bolted to the attached plate. This provided a flat surface, normal to the blade spanwise axis, on which the clevis for attaching the hydraulic cylinder could be mounted. A photo of the modified blade section mounted in the Ft. Eustis facility is shown in Figure 22.

Figure 22. - Mod-0 aluminum blade mounted in the Ft. Eustis facility.
